**Nolen's Marine Surveying**  
SOCIETY OF ACCREDITED MARINE SURVEYORS (SAMS)  
ACCREDITED MARINE SURVEYOR

**2018 / JEANNEAU / NC 895 OFFSHORE**

# **Report of Marine Survey**

**OCTOBER 29, 2021**

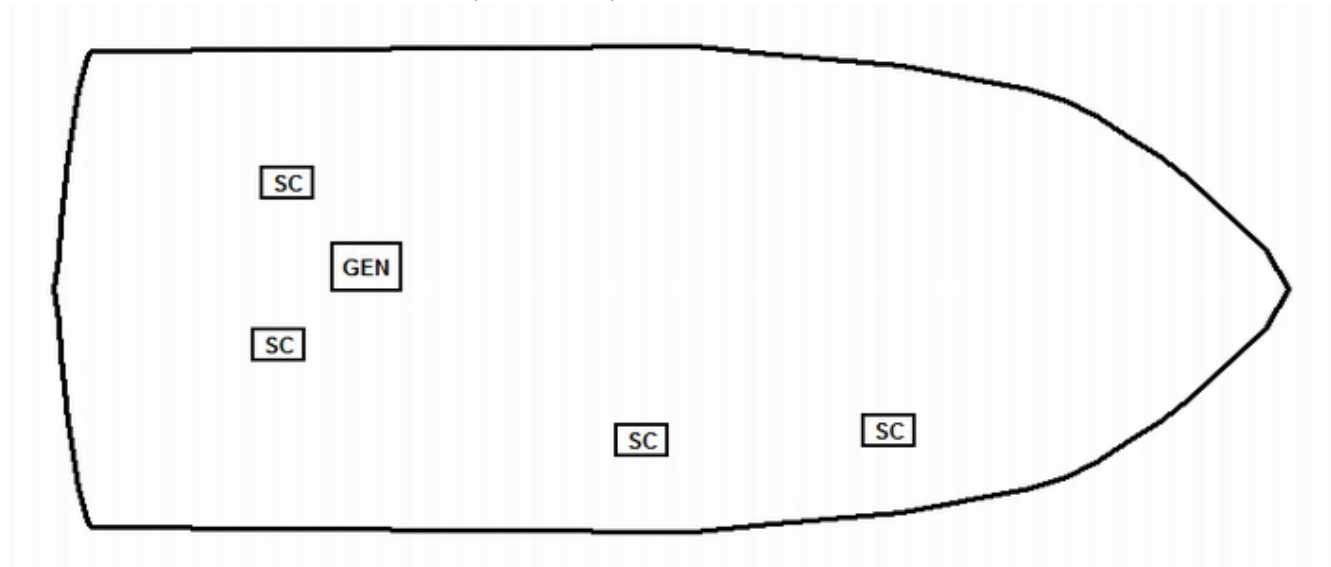
THRU-HULLS BELOW WATER LINE (DIAGRAM):

**THRU-HULLS LIST**  
1.) Air conditioner's raw water intake.  
2.) Raw water intake for flushing the toilet.  
3.) Direct overboard discharge ball valve for black water holding tank.  
4.) Generator's raw water intake.

**NOTE: It is recommended that all below the water line thru-hulls have a proper sized wooden plug attached to function as emergency plugging device.**
